**NORWAY/UNITED STATES DESIGN PROTECTIVE
AIRCRAFT SHELTER (PAS) QUANTITY-DISTANCE
PROGRAM 1/3-SCALE TEST SERIES**

**Volume I of V
PAS 1-4 Summary**

Final Report

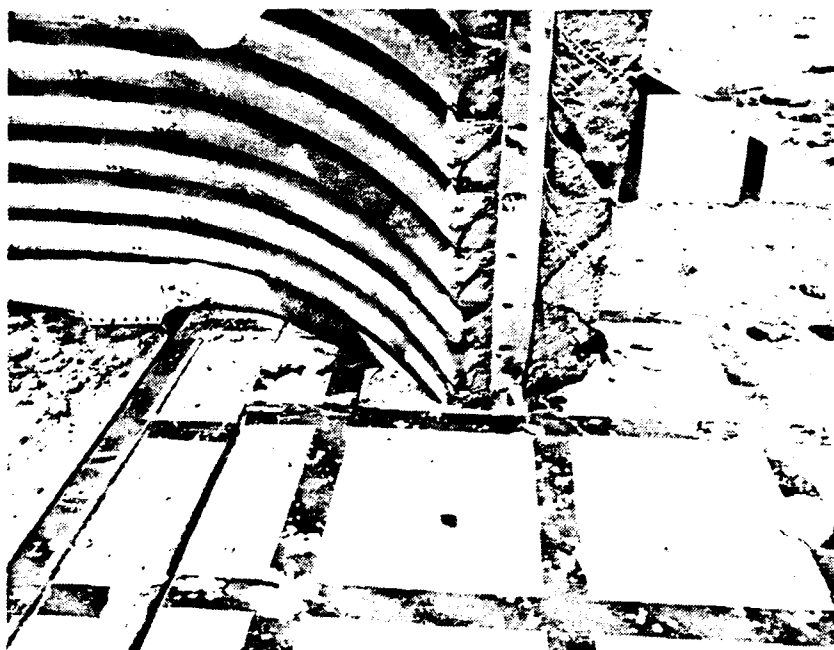
The major damage to the apron slab occurred when it was struck by the corner of the front wall and headworks section as it fell back (Fig. 105). A 30-mm wide gap was noted between the front foundation and the apron slab (Fig. 106). The gap ran the full length of the apron slab.

Figure 105. Damage to apron slab, PAS-3.

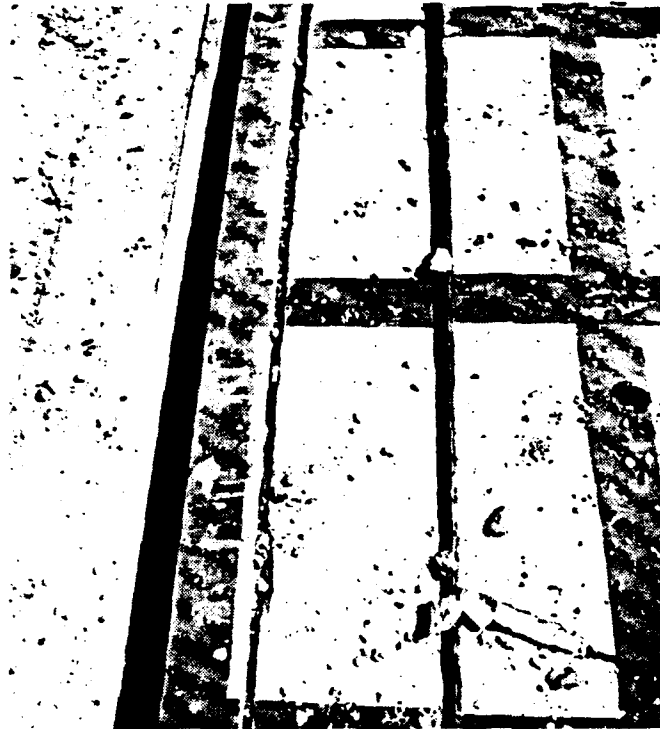
Figure 106. Gap between foundation and apron slab, PAS-3.

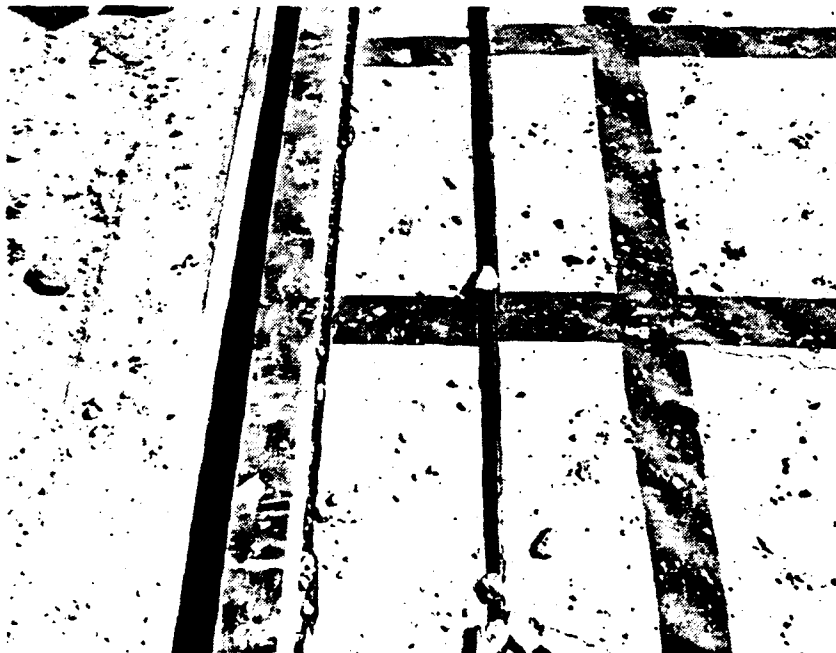
The front top plate of the door trench was found bent down and inward, resulting in a separation between the edge of the plate and the front foundation (Fig. 107). The area of damage was limited to the region between the door hinge pins. This damage is probably due to the forced rotation of the front door about its lower edge.

Figure 107. Top plate of door trench and front foundation, PAS-3.

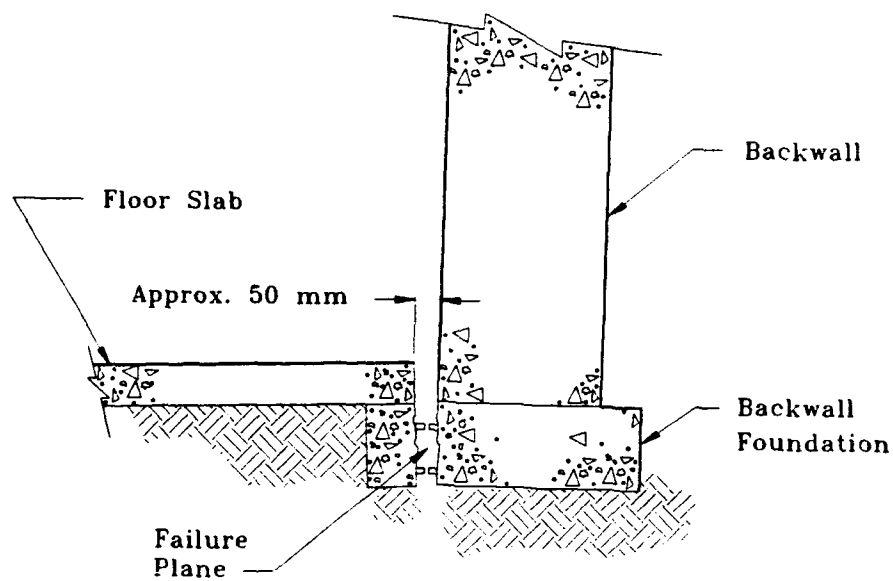
The front of the backwall foundation was still covered by the floor slab. Through a gap between the floor slab and backwall, the foundation was seen to have split vertically. The failure plane corresponded with an extended plane of the inside face of the

backwall (Fig. 108). The top bars in the transverse stirrups crossing the plane were observed to have failed in tension at the face of the fractured concrete. There was no indication of upward movement of the backwall foundation.

Figure 108. Section: Failure plane in backwall foundation, PAS-3.

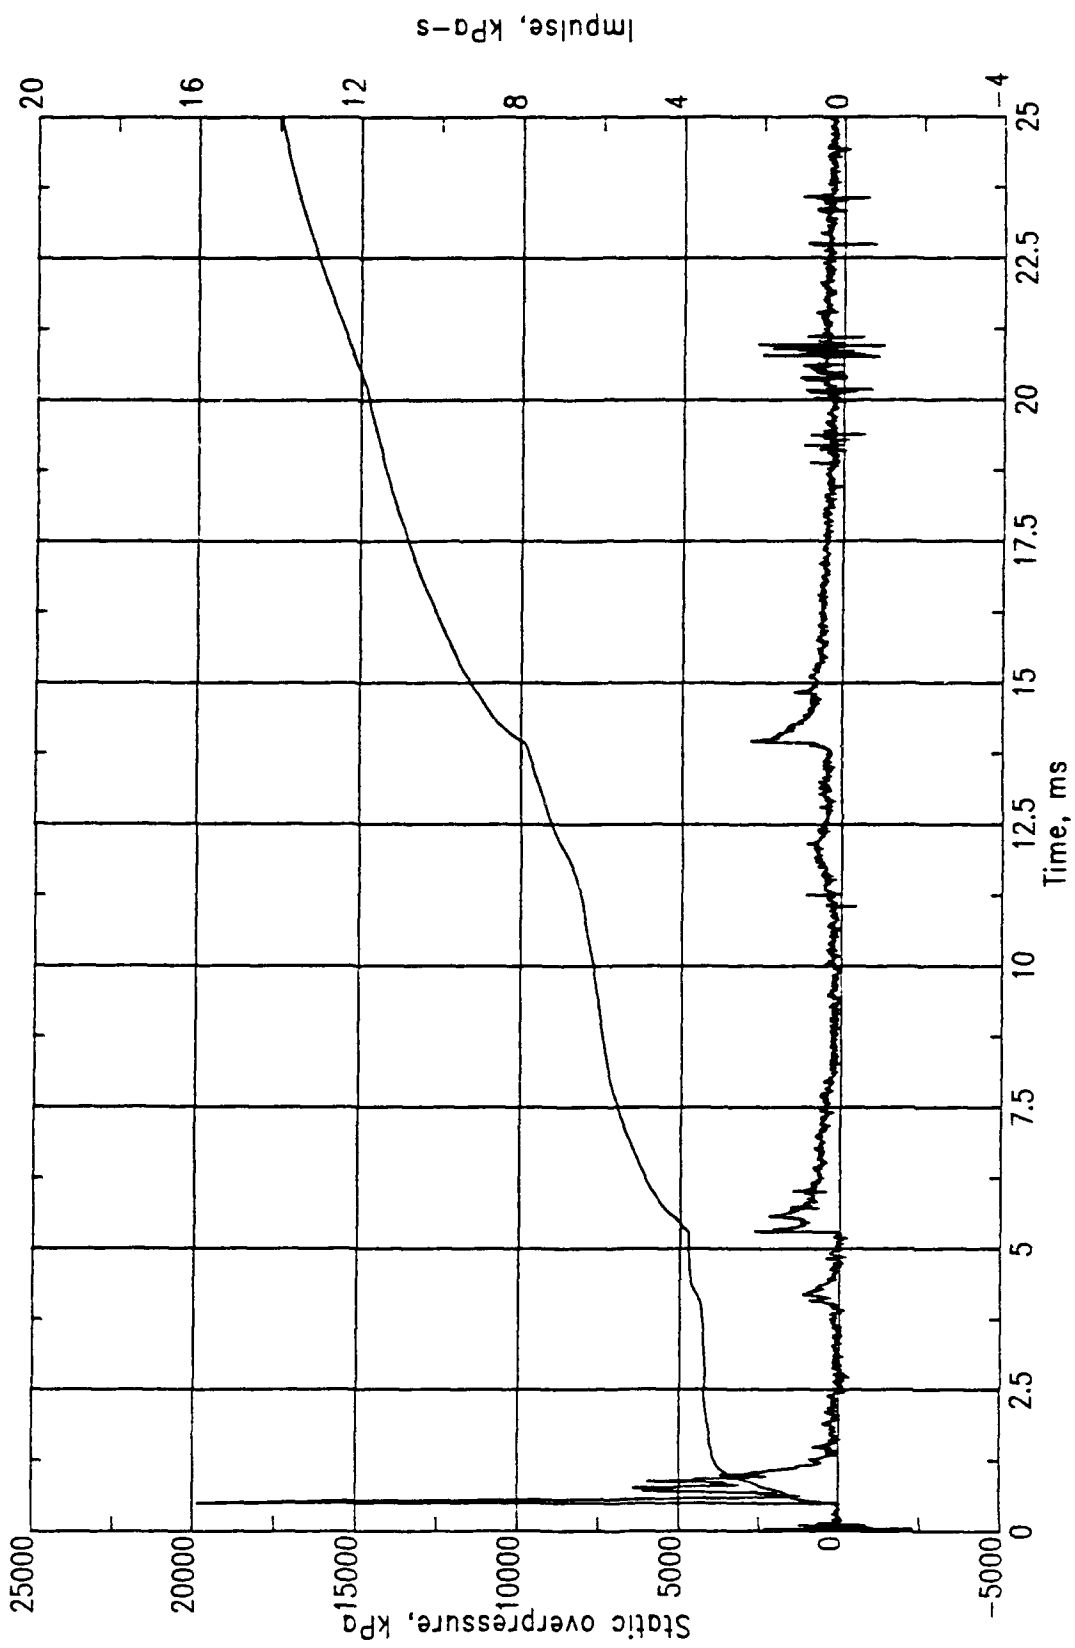
Figure 110. PAS-3, MN 0604.

The maximum pressure recorded inside the structure was 19.86 MPa at MN 604 (Fig. 110). This gage was located on the ceiling directly over the charge. This measurement failed at about 28 ms, probably as a result of the breakup of the structure. The INBLAST code predicted 28.8 MPa at this location. The GUSH code provided a value of 18.7 MPa.

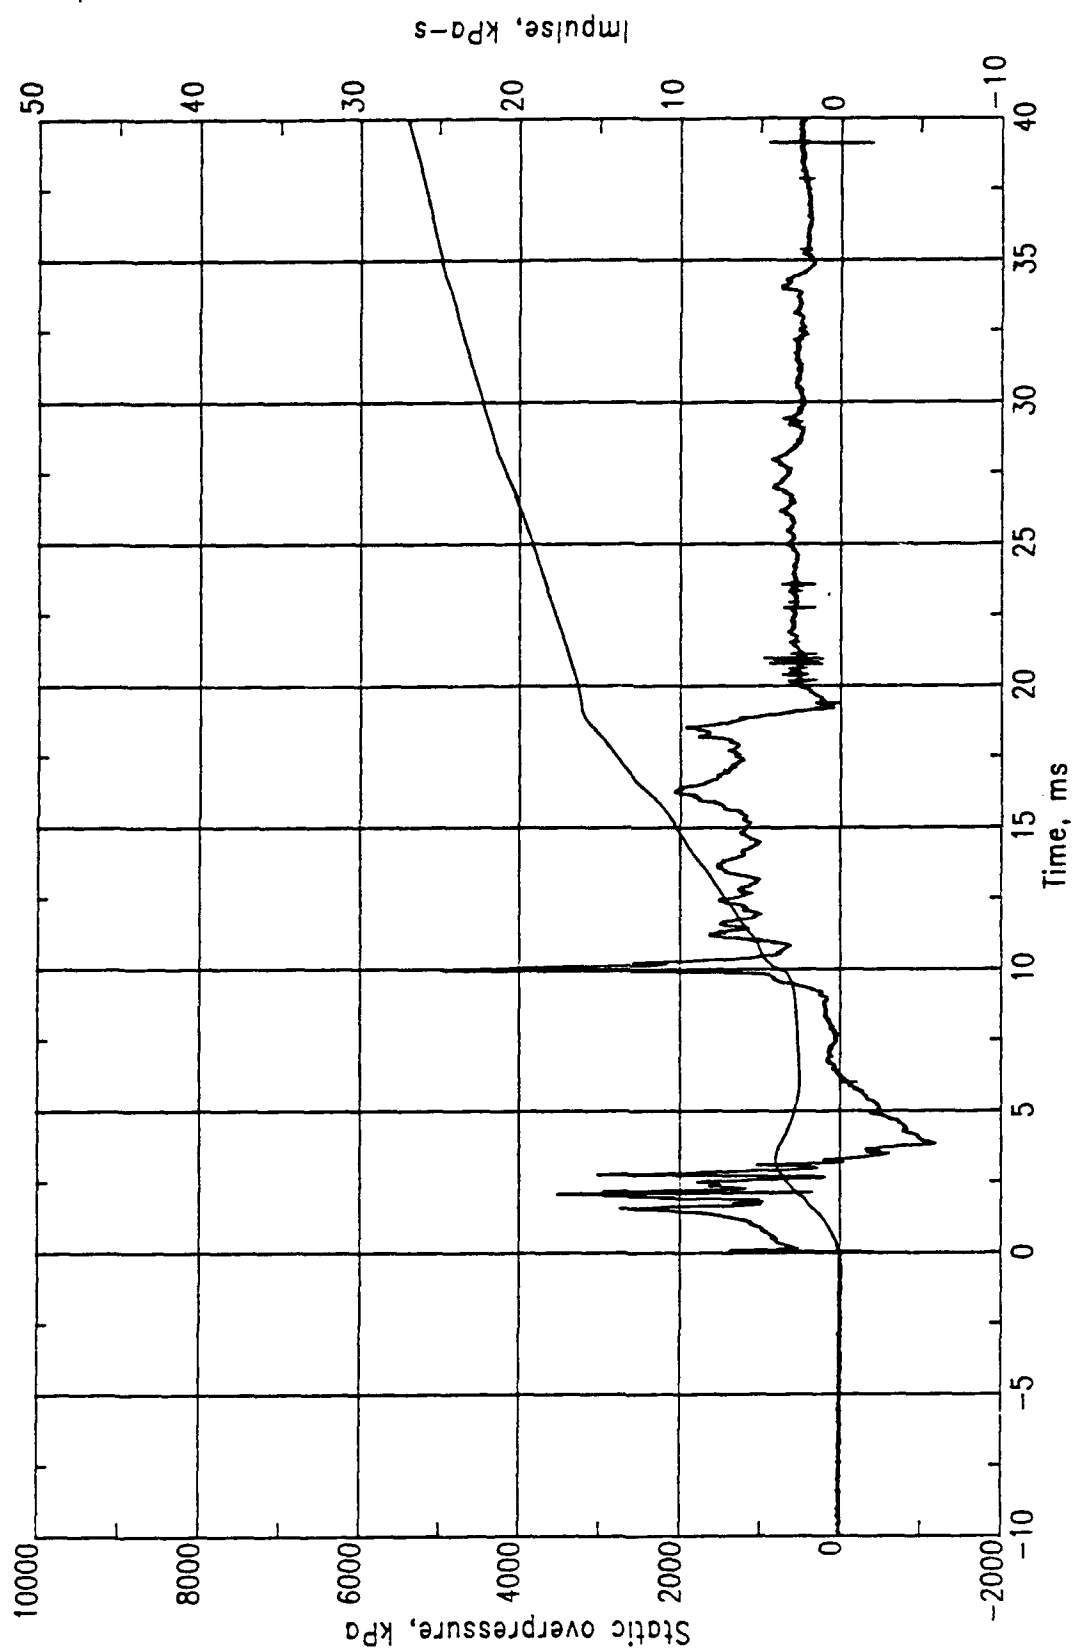
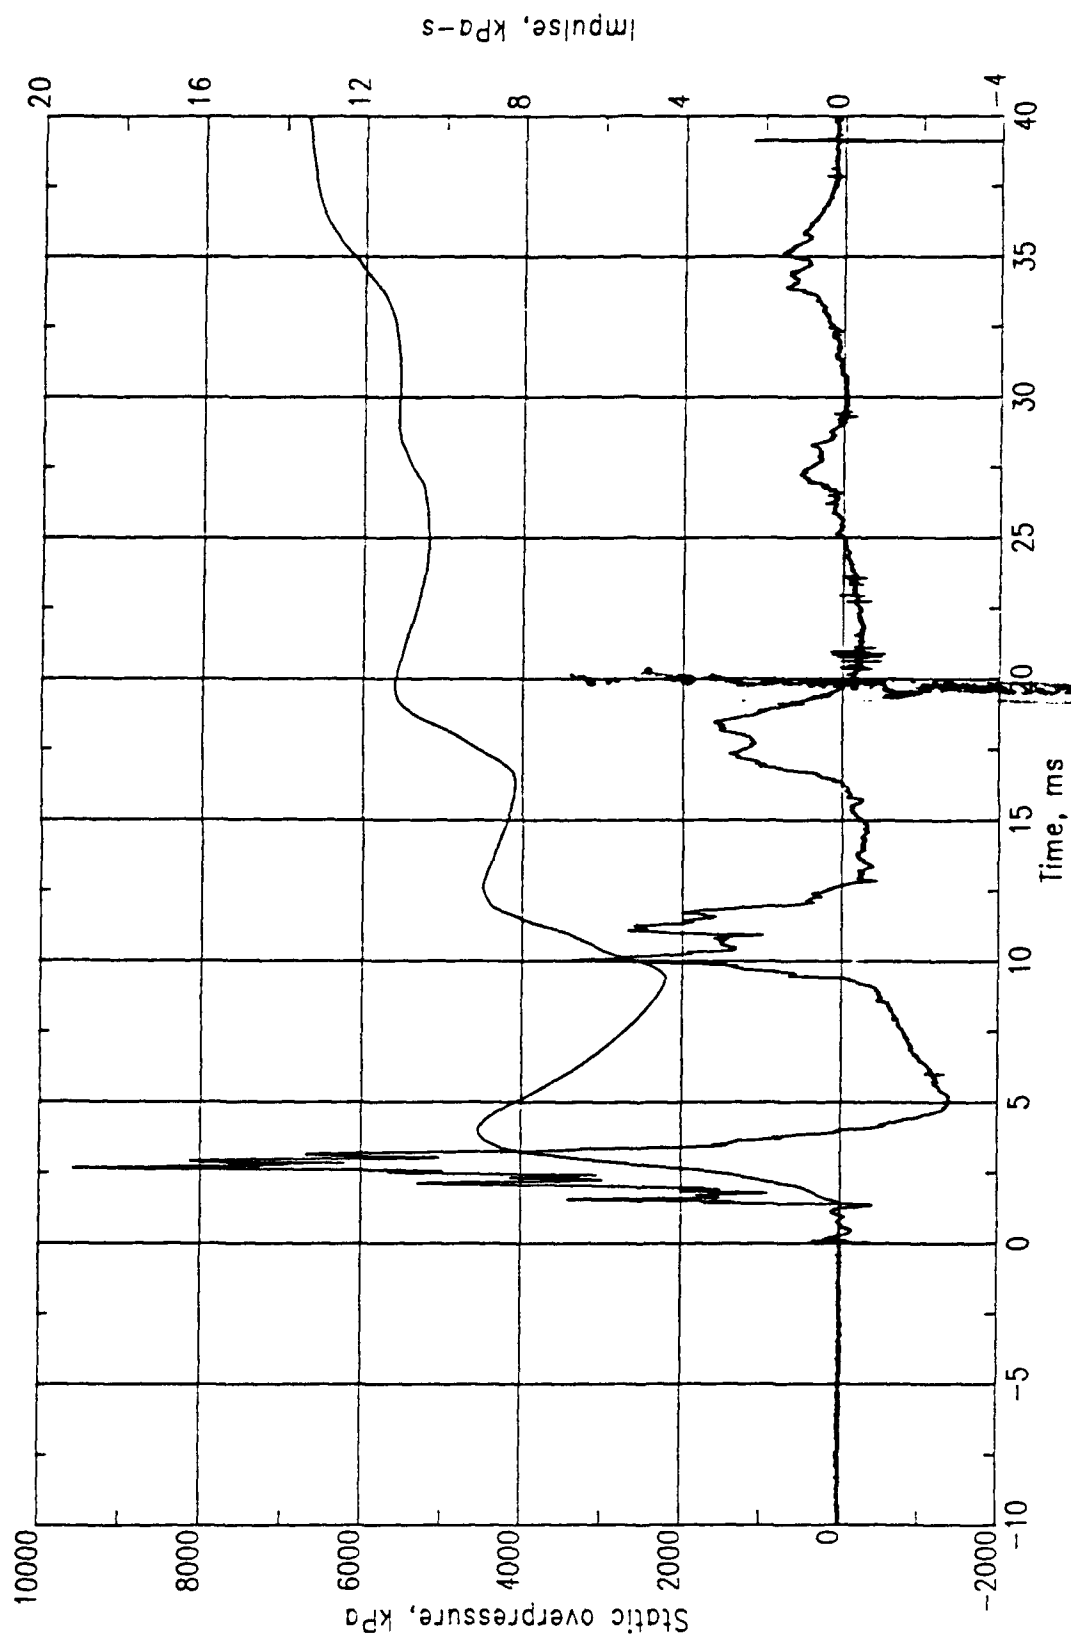
Figures 111 and 112 show the pressures recorded on the floor near the sides of the structure in the same plane as MN 604. These two gages did not show the same degree of symmetry observed in PAS-1. Although the timing of the early peaks is similar, the magnitudes of the first two peaks are quite different. The first two peaks of MN 602 (Fig. 111) are 3.5 MPa and 5.0 MPa. This record also shows a positive baseline shift at $t = 0$. The corresponding peaks of MN 603 (Fig. 112) are 9.5 MPa and 3.4 MPa. The INBLAST and GUSH code predictions for the first peak at MN 603 were 5.0 and 9.6 MPa, respectively.

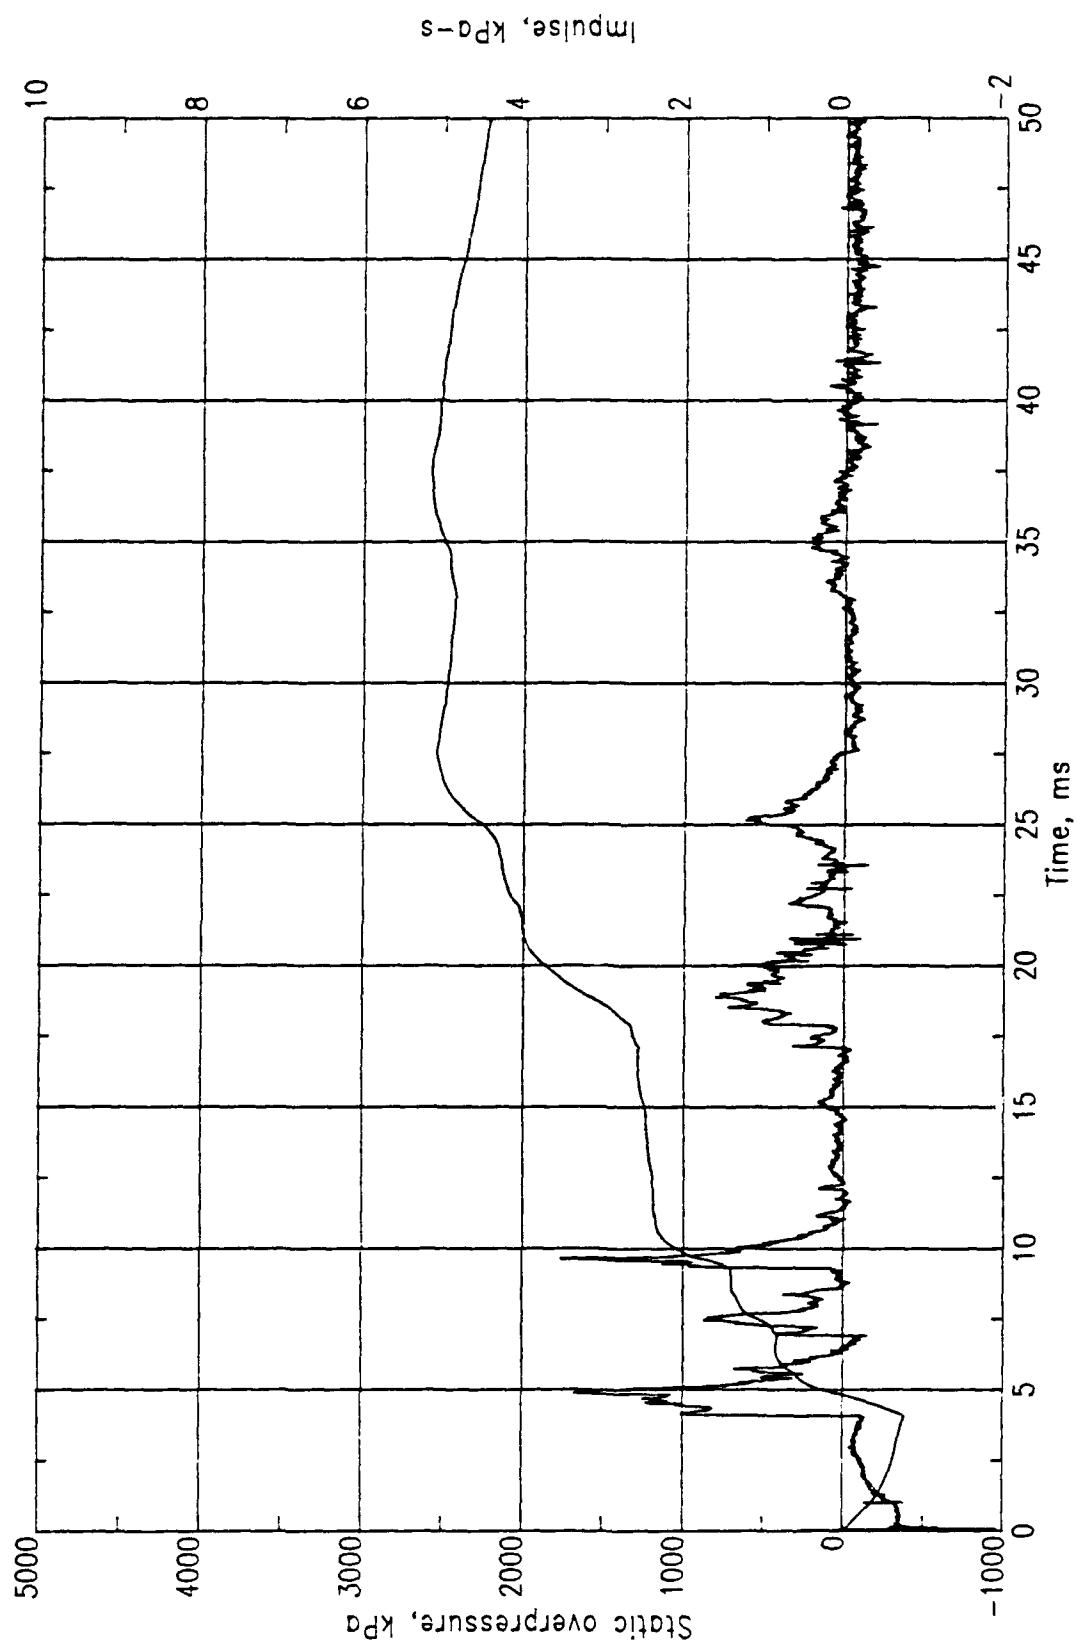
Figure 113. PAS-3, MN 0402.

The only pressure measurement made on the inside surface of the front door in the PAS-3 test was MN 402 (Fig. 113). This gage showed a peak pressure of 1.7 MPa, but a negative baseline shift at $t = 0$ makes this peak somewhat uncertain. The INBLAST code predicted 2.08 MPa at this location. Measurement Number 202 (Fig. 114) located in the backwall at about the same range and height from GZ, but off of the structure centerline, shows a peak of 1.8 MPa. The INBLAST prediction for this location was also 1.8 MPa. The spike that occurs in MN 202 at about 6 ms appears to be noise and not real data.

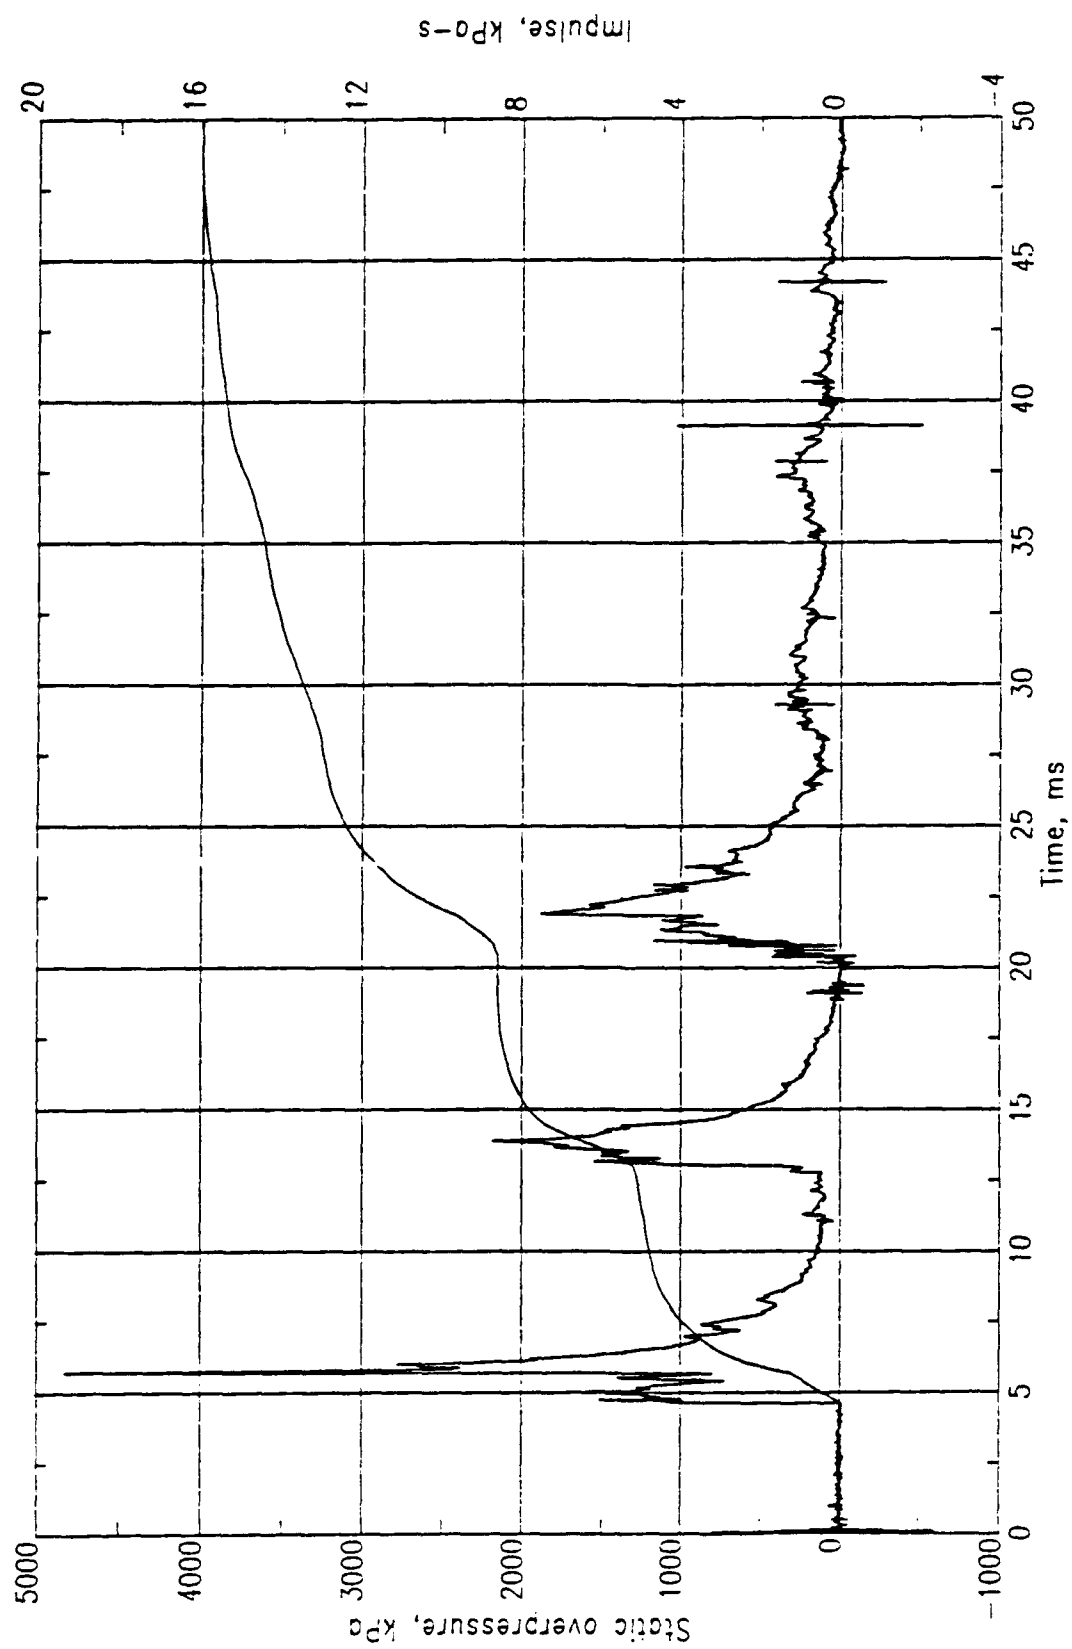
Figure 115. PAS-3, MN 0501.

Measurement Number 501 (Fig. 115) located in the floor at the front corner of the shelter showed a peak pressure of 4.8 MPa. Measurement Number 102 (Fig. 116) located in the floor at the rear corner of the shelter showed a much higher peak of 7.9 MPa at the same time. Although the three peaks in both records occurred at about the same time, those of MN 102 were consistently higher than those of MN 501. The INBLAST prediction for these two locations was only 1.66 MPa.

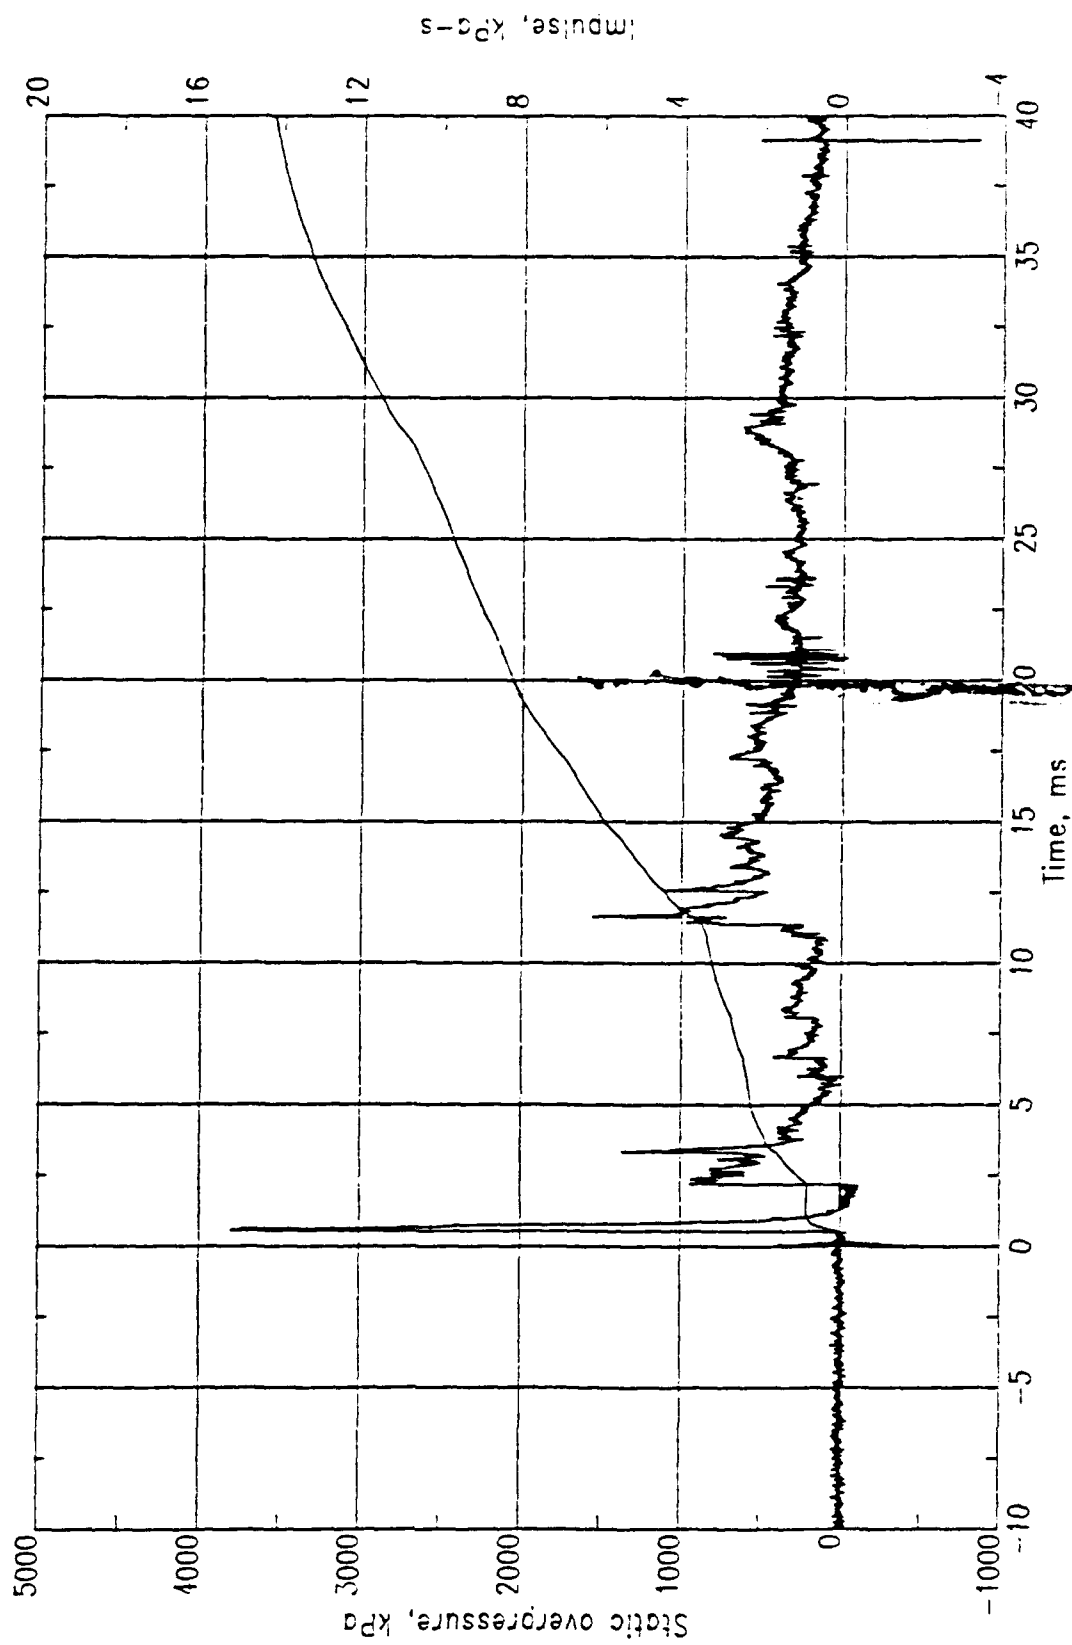
Figure 117. PAS-3, MN 0601.

Measurement Number 601 (Fig. 117) was made in the floor 1.85 m from GZ towards the side of the shelter. It shows a peak pressure of 3.7 MPa. The INBLAST code predicted 5.8 MPa at this location. Measurement Number 301 (Fig. 118) was made in the floor 2.84 m from GZ toward the front door. This record shows a peak of almost 5.0 MPa. However, MN 301 also shows a positive baseline shift of about 1.5 MPa at $t = 0$. If this shift were subtracted from the peak of MN 301, it would show better agreement with MN 601.

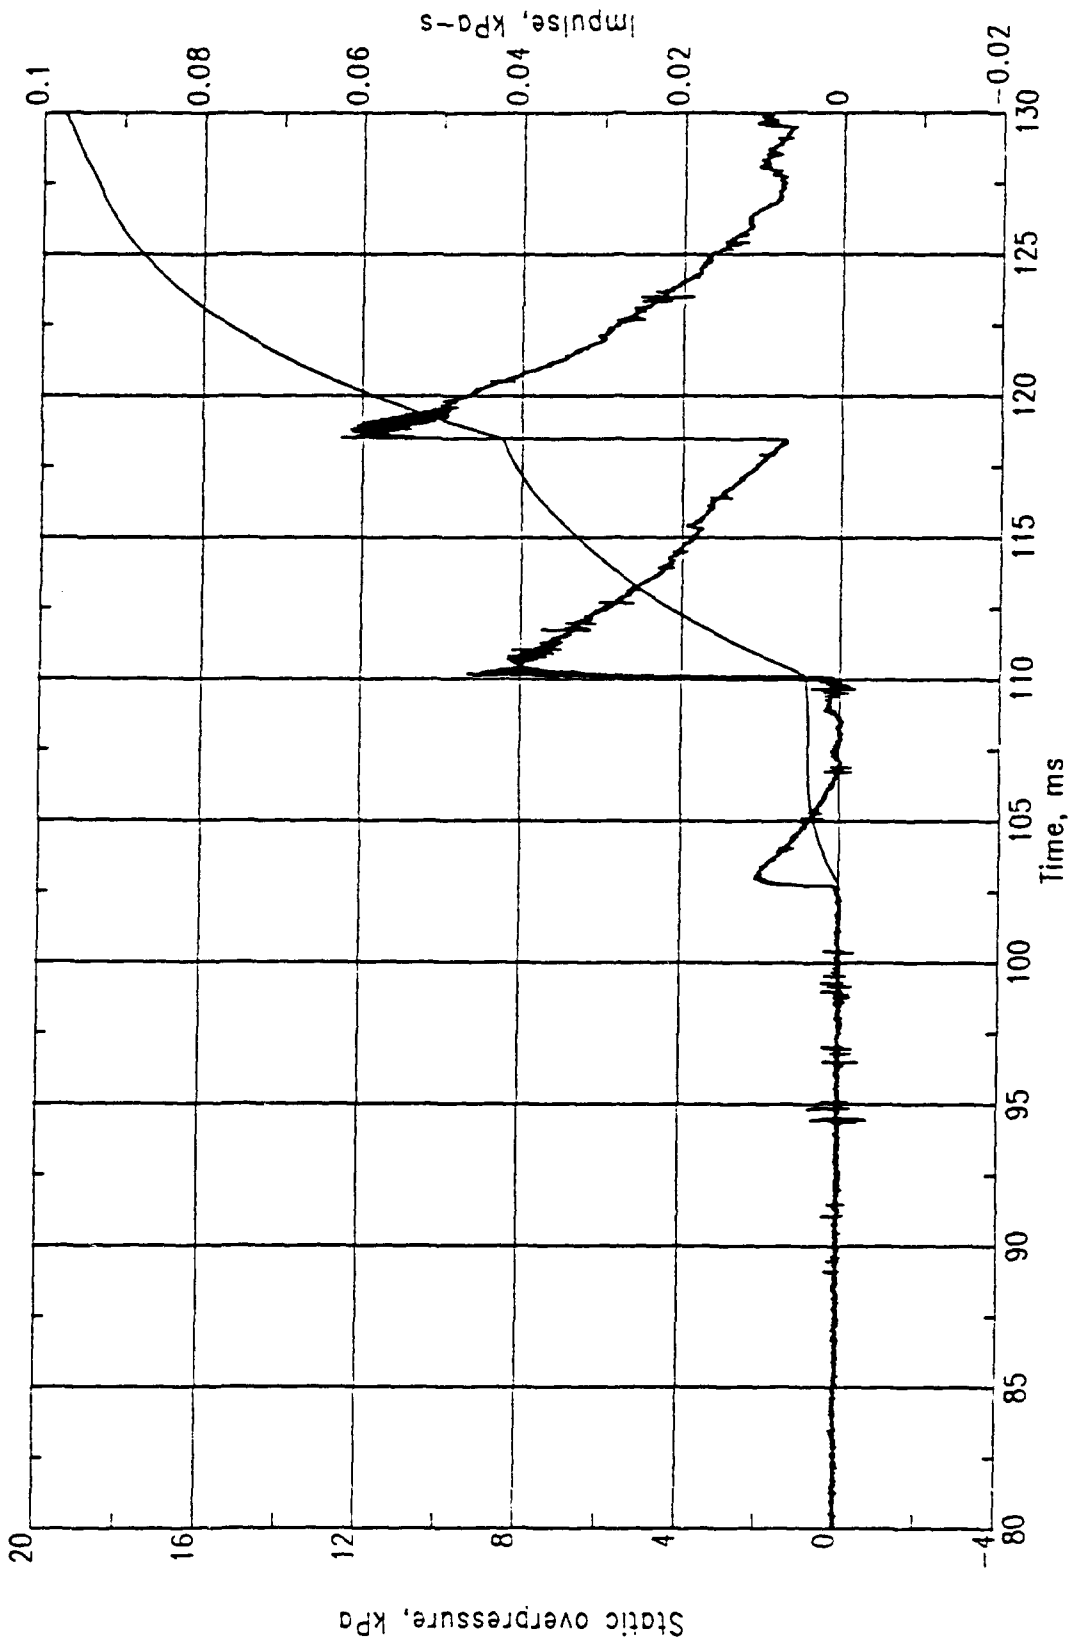
Figure 119. PAS-3, MN 0703.

lines. Many of the measurements exceeded 6.9 kPa. The highest pressures were measured at the front of the structure. This is probably a result of the early failure of the front door. On the centerline of the structure at a range of 40.7 m from GZ, MN 703 recorded a peak pressure of 12.5 kPa (Fig. 119). At a range of 50.7 m from GZ, MN 704 showed the peak pressure had decreased to 8.9 kPa (Fig. 120). At the side of the structure the peak pressure had decreased to 5.9 kPa at a range of 40.0 m from GZ. At the rear of the structure the peak pressure had decreased to 6.5 kPa at a range of 30.3 m from GZ. The distribution of pressures at either side of the structure was nearly identical with only slight differences measured at the same ranges. The lowest pressures were measured at the side of the structure.

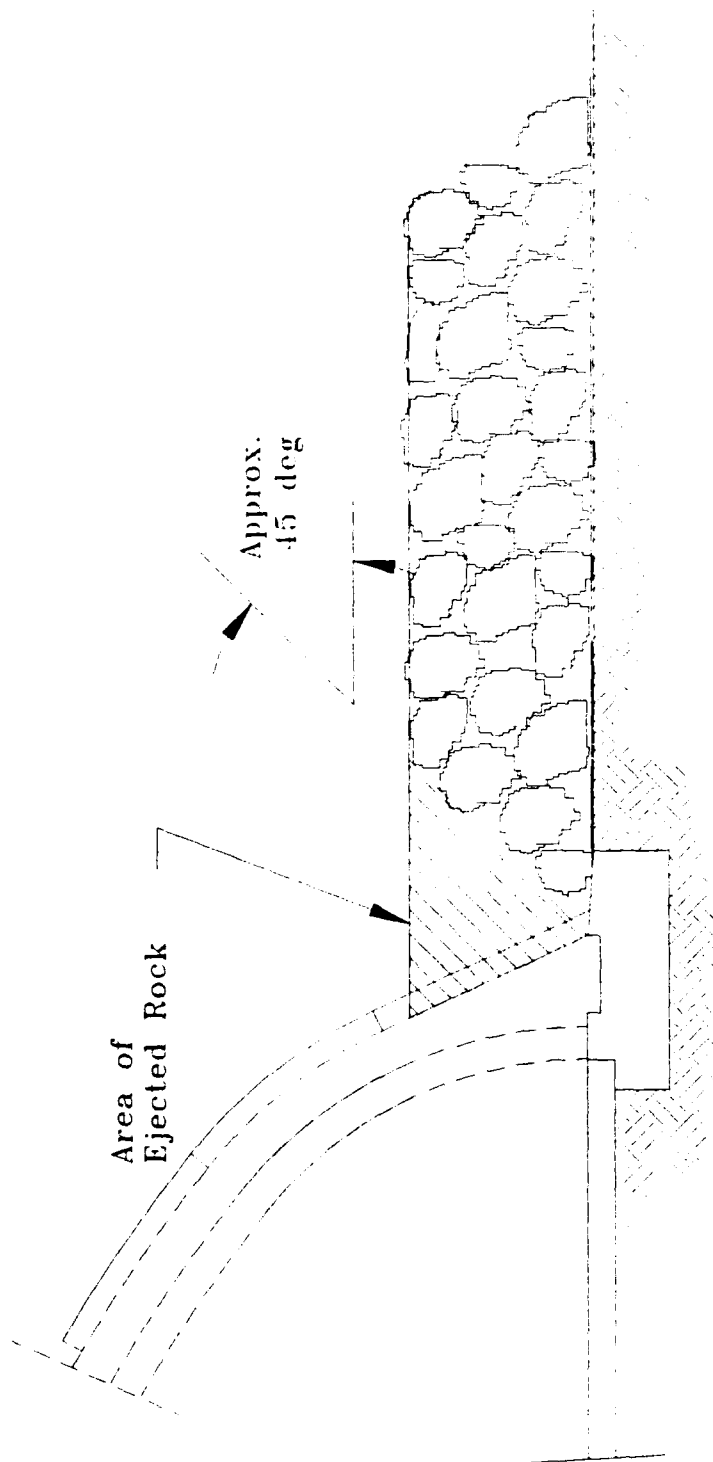
Figure 122. Section: Rock rubble berm, PAS-3.

A portion of the rock rubble berm adjacent to the arch was blown upward and out during the test (Fig. 122). The rocks remaining in the berm were relatively undisturbed by the test. High-speed photography shows that the rocks at the sides of the structure were thrown out at trajectories of 75 deg or less. Individual pieces of rock were a little difficult to follow, but in a few instances their early upward velocities were on the order of 14 to 15 m/s. Ground-impact velocities of pieces of rock rubble varied from 7.5 to 11.5 m/s.

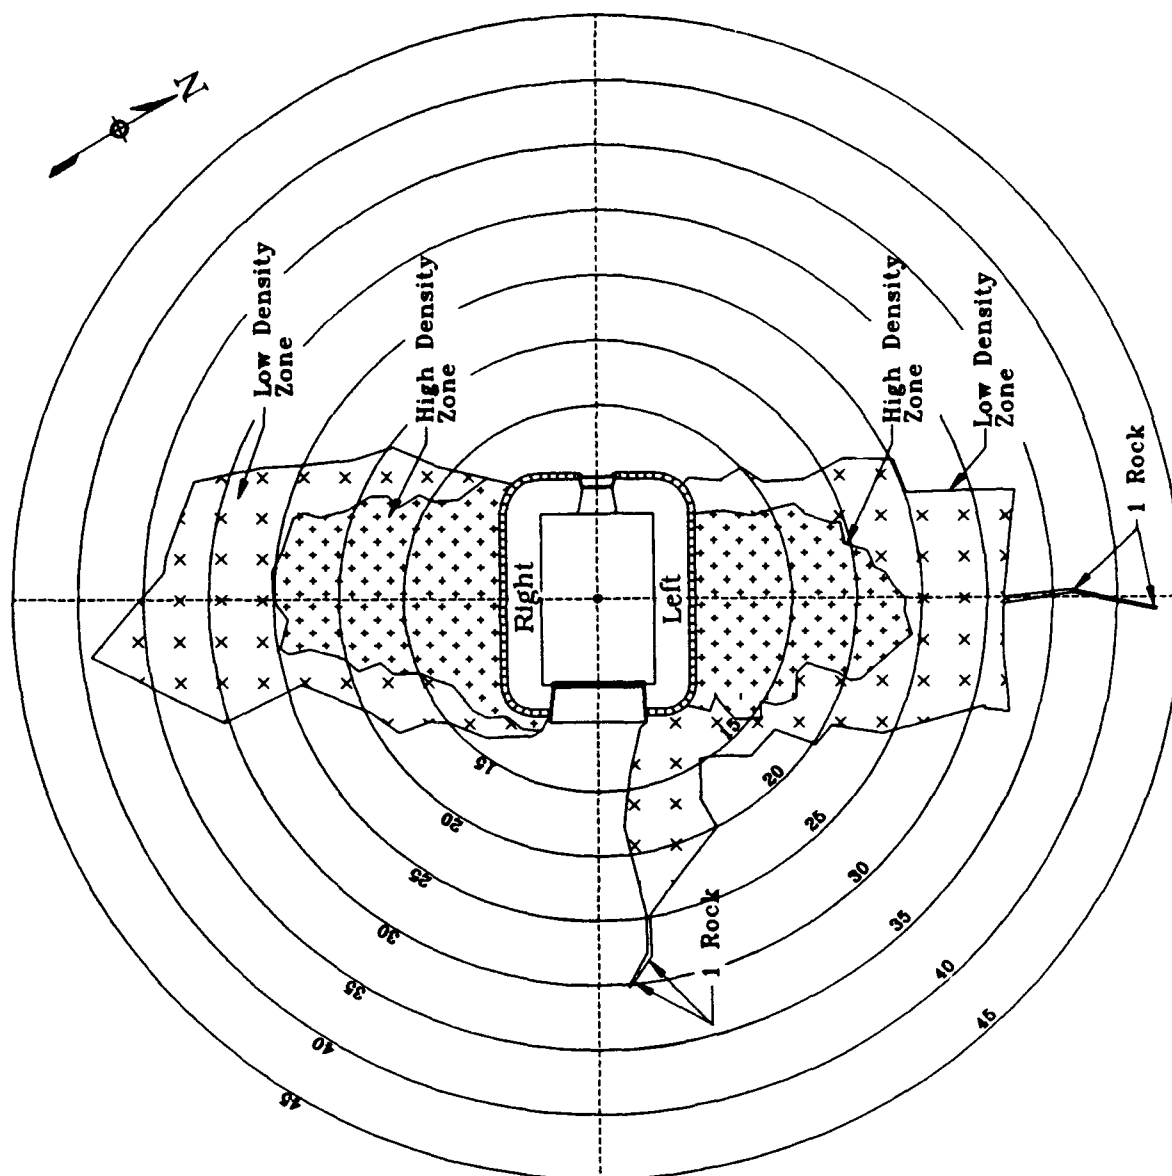
Figure 133. Distribution of debris from rock rubble berm, PAS-3.

rock distribution, and the boundary between the two areas of different densities were surveyed. This information is illustrated in Figure 133.

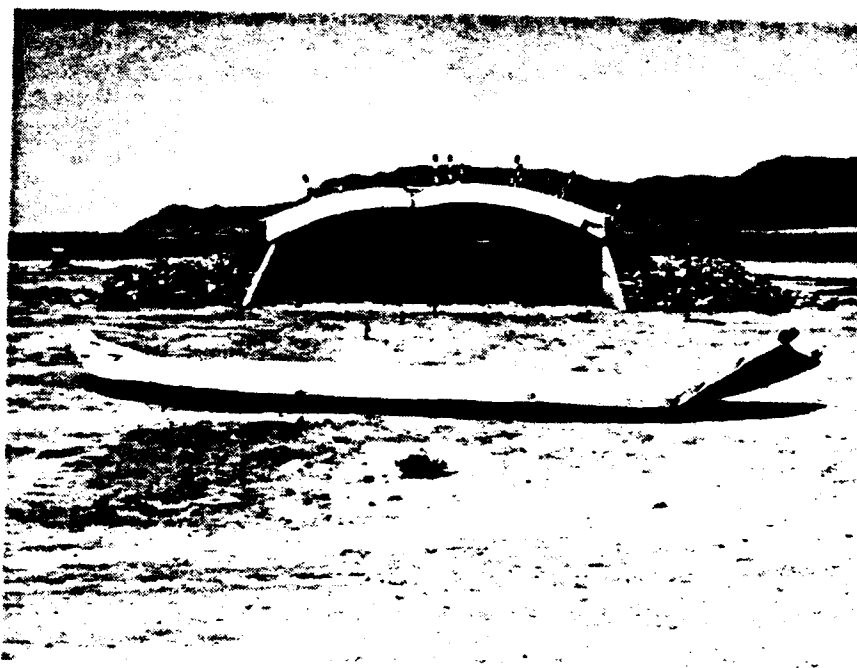
Figure 149. Posttest location of front door, PAS-2.

The front door was again blown out of the structure very quickly. Smoke was observed along the top edge of the door at about 6 ms, and it appeared to separate from the door frame at about 25 ms. The door rotated about its lower edge and was flat on the front apron at about 140 ms. It then skidded outward along the ground and came to rest at about 19 m from the front of the structure (Fig. 149). The velocity of the door could not be determined because its early movement was obscured by smoke, flame, and dust.

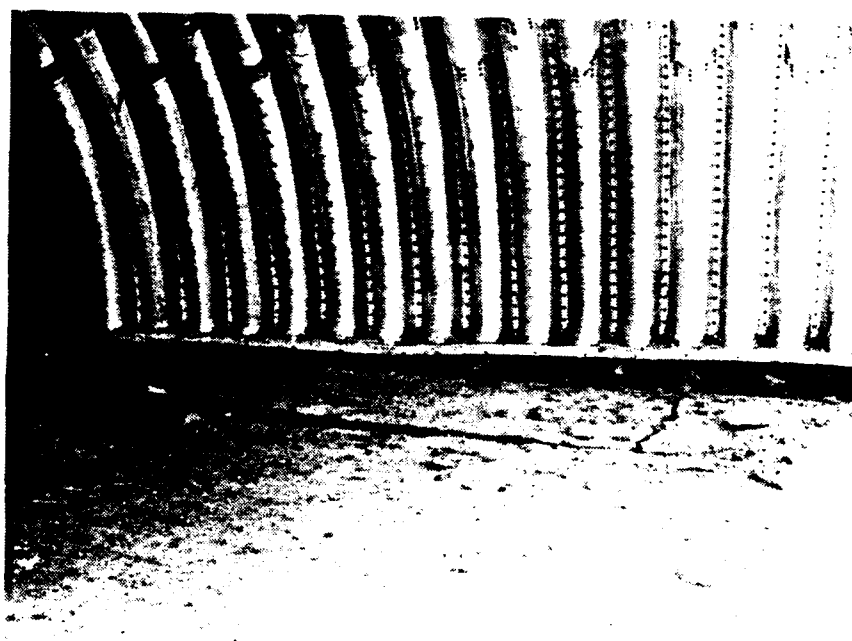
Figure 166. Anchor bolt pull-out at base of arch, PAS-2.

About half of the anchor bolts for the arch liner base channel were found still embedded in the foundation. The channel had been pulled up over the bolts and remained attached to the sections of the arch. The rest of the anchor bolts had pulled out of the foundation, along with the channel, and were still attached to the base edge of the arch sections (Fig. 166).

Figure 166 also shows a crack in the floor slab running parallel to, and about 550 mm from, both sides of the arch and the backwall. The crack varied in width from a few millimeters up to about 50 mm, and the average vertical displacement between the two sides of the crack was 15 mm. The concrete at the edges of the crack was severely fractured and crushed. The floor slab sloped upward from the crack to the arch foundation and backwall. The joint between the floor slab and arch foundations was still tightly closed. At both back corners, another large crack ran diagonally from the intersection of the cracks (parallel to the sides) back to the corner of the arch and backwall (Fig. 167).

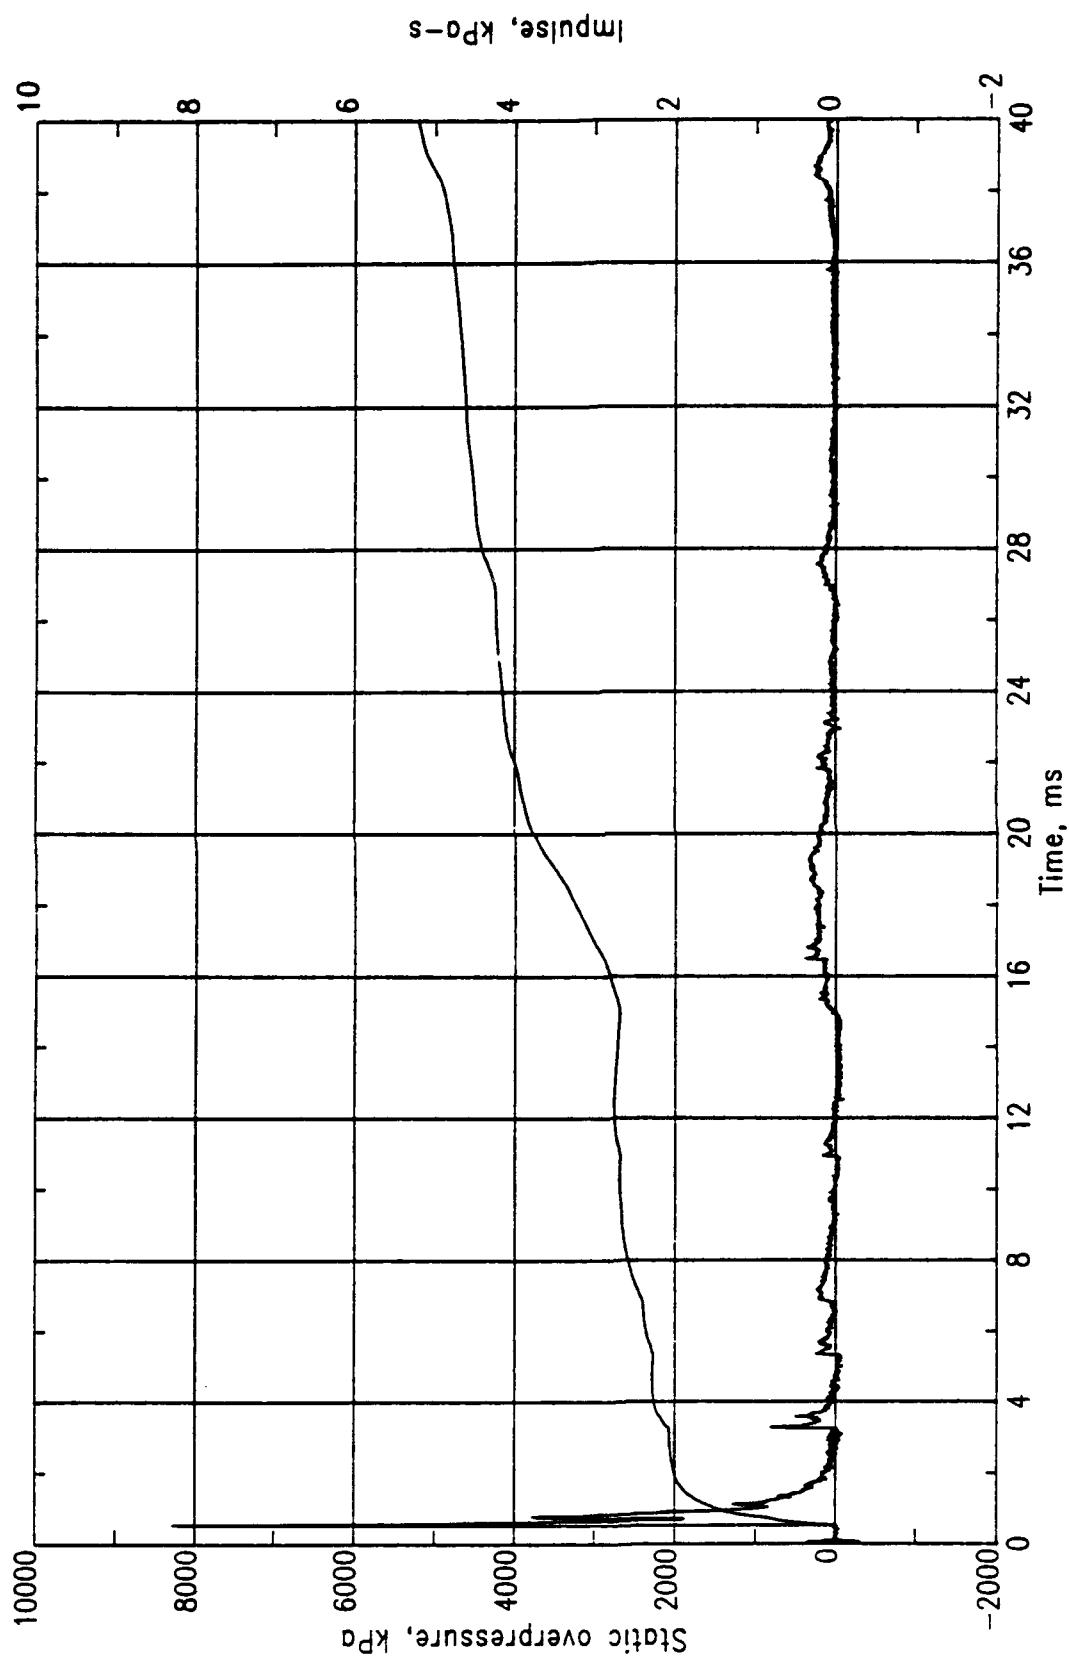
Figure 174. PAS-2, MN 0604.

The maximum pressure recorded inside the structure was 8.2 MPa at MN 604 (Fig. 174b). This gage was located on the ceiling directly over the charge. The INBLAST code predicted 12.2 MPa at this location. Figures 175 and 176 show the pressures recorded on the floor near the opposite sides of the structure in the same plane as MN 604. These two gages showed symmetry in the magnitudes and TOAs of the first few peaks of the two records. The first peak of MN 602 was 1.22 MPa (Fig. 175); the first peak of MN 603 was 1.29 MPa (Fig. 176).
